Amateur Radio
Woodcreek, Texas

JRS Frequency Counter 1972 Restoration/ Rejuvenation

Rev 1.00
Jim Satterwhite, K4HJU

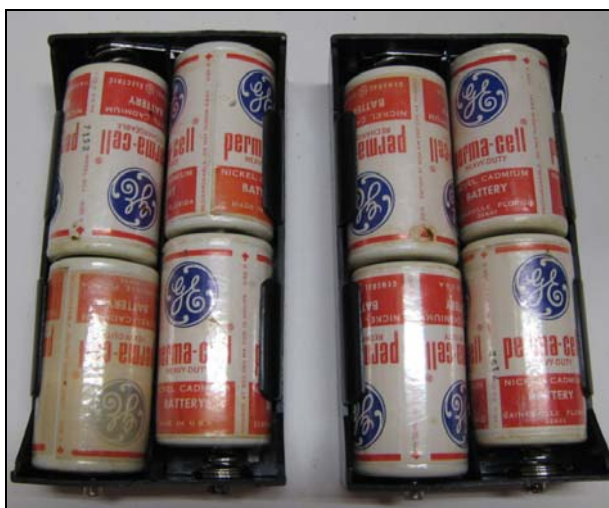
Figure 1-3 D Cell Ni Cad Batteries

One interesting aspect of digging this out is that the original batteries were in the unit. There were eight D cell Ni Cads. The contacts on the original battery holders were not working well so I found some more modern battery holders.

The really interesting thing is that when I attempted to charge the batteries, they took the charge and held it. I consider this phenomenal for 46 year old Ni Cads. They have a date stamp of 52nd week of 1971.

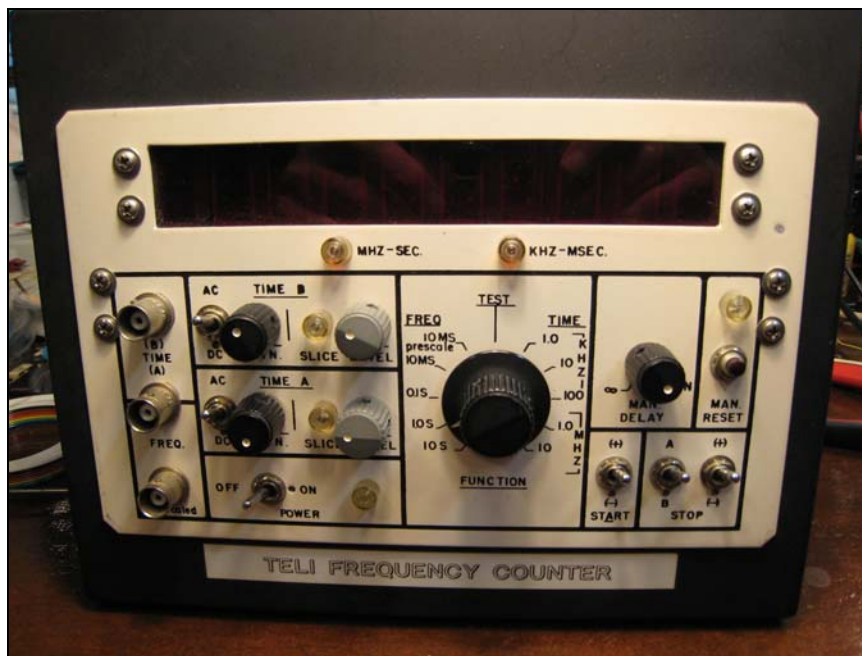
Figure 1-4 "Production Counter"

The "production" counter is a bit more compact, although the wiring, to me, is a real mess.
